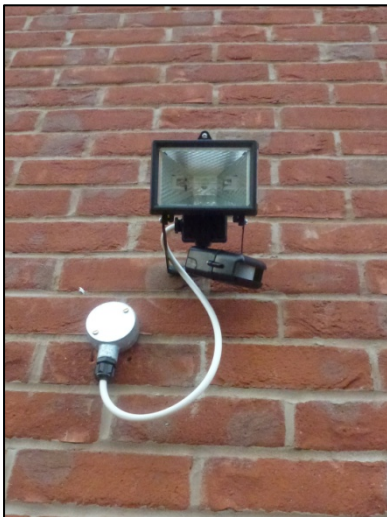
2nd Attempt by ClarksonEvans

1. Holes left in the brickwork will cause moisture ingress and over time will cause the brick to crumble. I know this from costly experience.
2. Due to the length, why not use black flex when everything else is black?
3. Why such a long distance between the cable connection point and the light fitting
4. Installation looks untidy, it could be at least clipped/cleated
5. The light fitting looks as if it is an extremely cheap one that will be rusting within 12 months

Overall an unsightly finish that has not had a lot of thought or care or....cost.

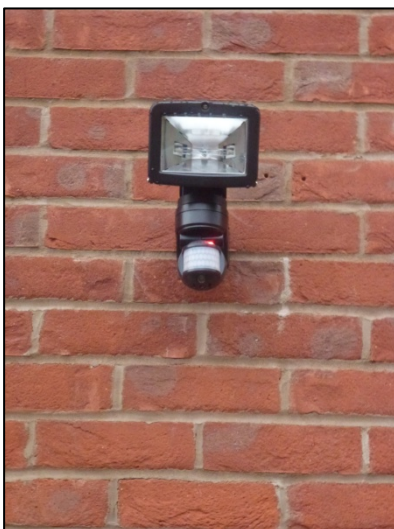
3rd Attempt by ClarksonEvans

This is their 3rd attempt after the owners passed the above comments on to TaylorWimpey - there are now 4 exposed holes in the brickwork.
