ENGINEERING INVESTIGATION & MONITORING SERVICES CLAIM REPORT

Property address	16 Kittlegairy Crescent Peebles EH45 9NJ			Plot no. (if known)	9
NHBC Claims reference no.	Eng. Project no.	NHBC claim handler	Claim section	Original builder	Date property finalised
17/28448	260967	C A Cambridge	3	Taylor Wimpey East Scotland	22/02/11

Brief received (or reason for re-issue of report)	Eng. referral no.	Report			
		Prepared by	Reviewed by	Issue no.	Date of issue
Initial assessment and report: please contact the homeowner as soon as possible to arrange a date to visit and investigate their claims that the mortar has failed and their garage is structurally unstable.	981455	J Aitken	C Orr	1	28/06/18

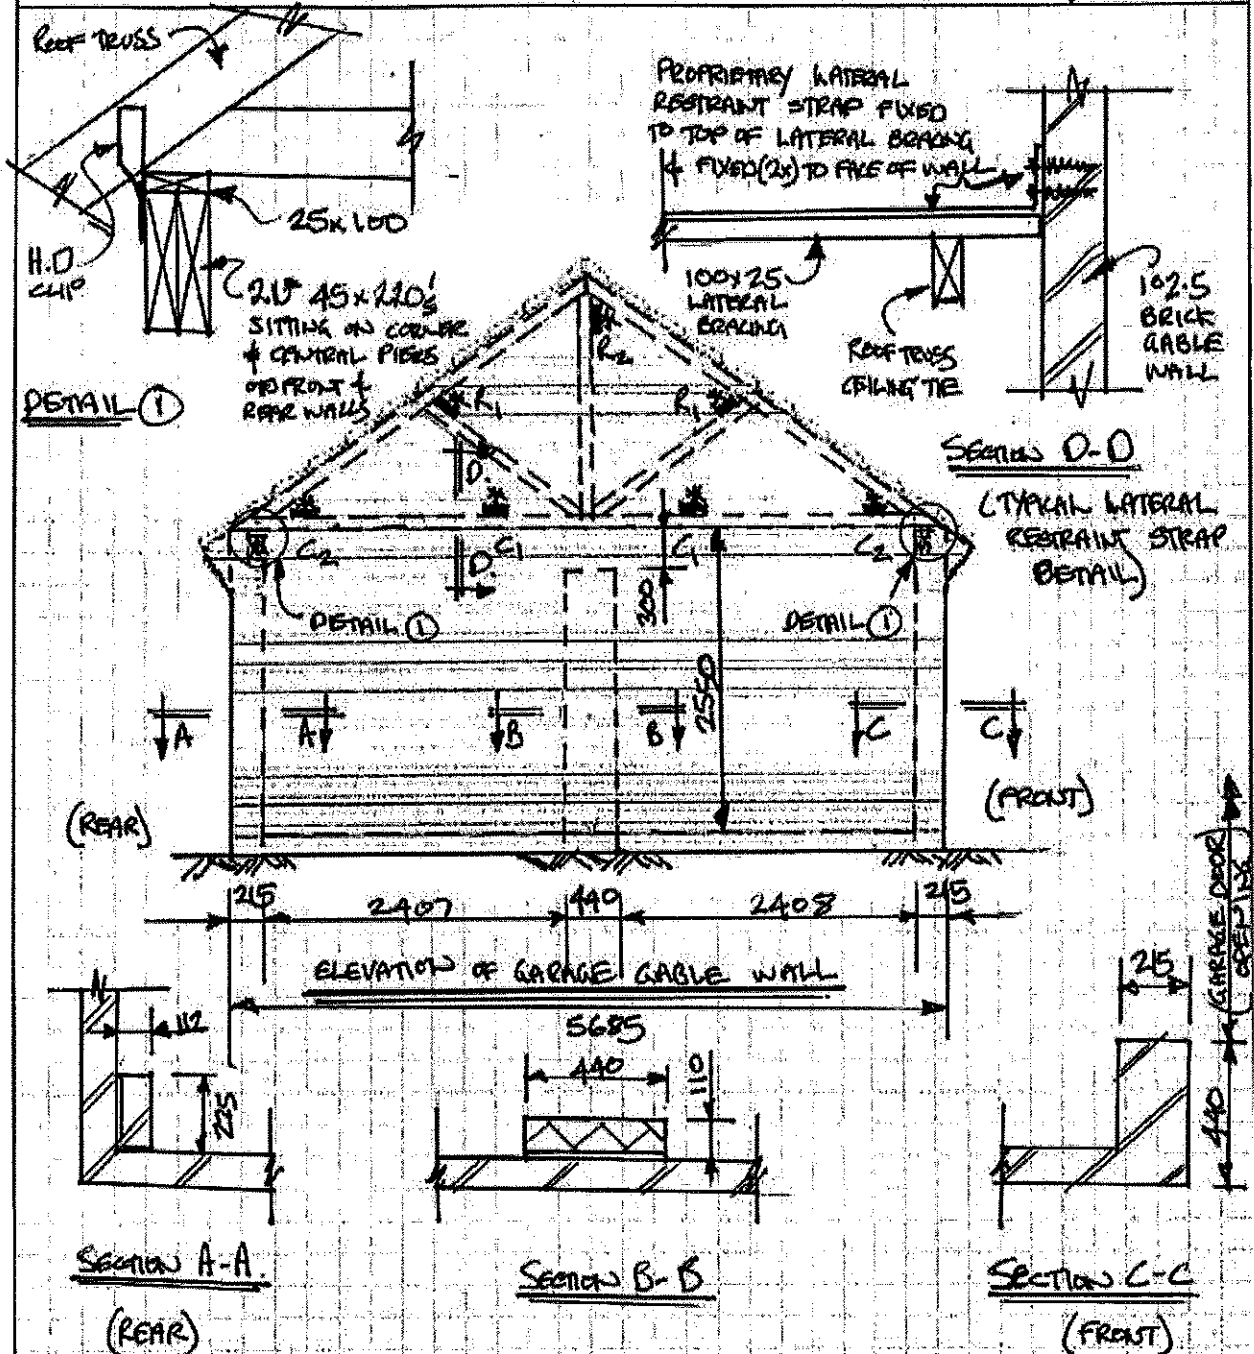
SK-O

Date of initial visit	10/04/18	In attendance	<ul style="list-style-type: none"> • Homeowner • John Aitken – NHBC Engineer
Damage inspected / recorded	Yes – see sketch No. SK – 01 for the as-built general arrangement of the gable walls of the garage.		
Level survey	No		
Plumb survey	No		
Vegetation survey	No		
Crack/level monitoring installed	No		
Trial pits / Boreholes	No		
Drain tests	No		
Other	No		
Site plan sketch appended	No		
Crack survey sketch appended	N/a		
Distortion survey(s) appended	N/a		
Trial pit logs appended	N/a		
Photographs appended	Yes – see plate Nos. 1.1 to 1.3, 2.1 to 2.20, 3.1 to 3.21 and 4.1 to 4.8.

C_1 = LATERAL RESTRAINT STRIP FIXED TO LONGITUDINAL BRACING (FULL LENGTH)
 C_2 = LATERAL RESTRAINT STRIP FIXED TO 25x100 TIMBER OVER 4 TRUSSES
 R = LATERAL RESTRAINT STRIP FIXED TO LONGITUDINAL RAFTER BRACING (FULL LENGTH)
 $(R_1 = \text{RAFTER}; R_2 = \text{APEX})$

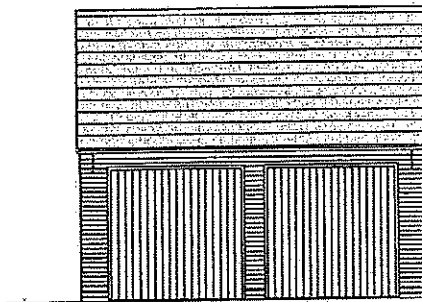
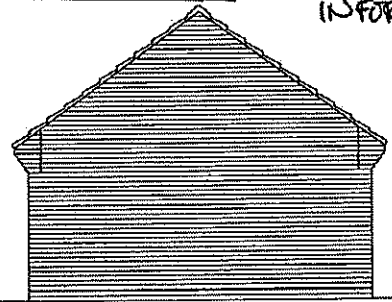
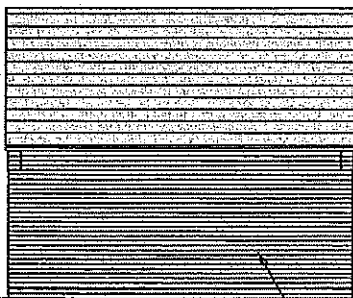
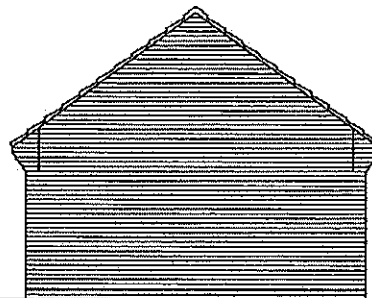
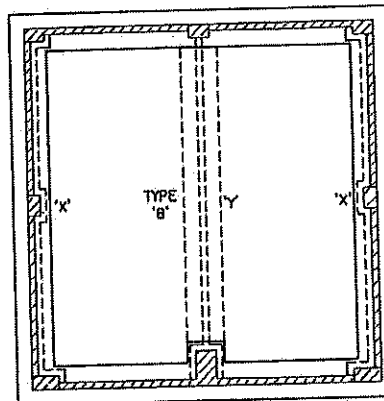
DETACHED DOUBLE GARAGE GENERAL ARRANGEMENT (FROM RECORDED INFORMATION)

- The report notes the original design information indicates that, for a garage with full height gables, the piers on the two gable walls should have been 1570mm long, not 440mm long as built (see also sketch No. SK – 02).

CONCLUSIONS (continued)	
Are there structural or health and safety concerns regarding the garage walls (continued)?	<ul style="list-style-type: none"> The holding down straps at the rear corners of the garage are fixed to brick piers that are built as vertical 'stacks' of 215mm x 102.5mm bricks – see plate Nos. 3.13, 3.14, 3.16 and 3.17. These piers do not appear to be bonded to the main wall, and the effectiveness of the holding down is questionable (some distress in the pier and the holding strap itself is apparent, and one of the fixings has split a brick – see plate No. 3.14).
Commentary / discussion on investigation and rationale for conclusions	<ul style="list-style-type: none"> Although Roberson Eadie has concluded that the rear and gable walls of the garage are understrength to resist the design wind loadings, this appears to be based on the assumption that the gable walls are not tied into the roof structure. However, the gable walls do appear to be effectively tied into the roof structure in accordance with Annex A of BS 8103-2 and relevant good practice – see sketch No. SK – 01, plate Nos. 4.1 to 4.8, and NHBC's Consistency Matters 6.1/12: Restraint straps to gable walls of garages. Roberson Eadie's calculations have been carried out in accordance with BS5628-1: "Code of practice for use of masonry. Structural use of unreinforced masonry". However, it is also common practice, and structurally justifiable, to design the external walls of small single storey non-residential buildings of this nature in accordance with Annex A of BS 8103-2: "Structural design of low rise building – Part 2: Code of practice for masonry walls for housing". A check of the as-built construction in accordance with Annex A of BS 8102-2:2005 indicates that the garage form, materials and construction are generally within the scope and recommendations of this code of practice. The only departure from the guidance in Annex A is that the overall height to the apex of the roof (approximately 4.5m) is more than the maximum of 3.6m in Annex A. Relevant extract from the foreword of BS 8103-2: 2005 are as follows: <ul style="list-style-type: none"> ➤ Low-rise buildings constructed within the limitations stated in the relevant clauses will not require additional specialist advice. ➤ It ought not to be expected that the recommendations made in this part can be proved by calculation as they are based on traditional prescriptive guidance substantiated by long experience. ➤ The recommendations of this code are intended to provide economic safe designs without the need for calculations of loading and strength criteria. ➤ This code is based on traditional simple design, within the scope of the code. The outputs are safe but not necessarily comparable with solutions derived from calculation-based design. ➤ For any conditions outside the limitations of this code, appropriate specialist advice is needed. ➤ It might be appropriate to consider a minor departure from the recommendations of this part and show adequacy by calculation. ➤ However, in cases where the recommendations of Clause 6 for conditions relating to a wall are not able to be met or are inappropriate then reference should be made to BS 5628-1. Although the overall height of the garage is more than limitations set out in Annex A of BS 8103-2, the length, height, thickness, materials, pier size, pier spacings, lateral restraint and roof bracing of the side gable walls are all well within the guidance. It therefore appears that this minor departure from the code (i.e. height more than 3.6m) was recognised in the original design, and consequently much wider piers (1570mm) were specified to provide adequate stiffness to the gable walls to resist the design wind loads.
