## Statement

This statement is in relation to audible cracking noises in intermediate floors in domestic buildings. It is written as a joint statement between NHBC, GPDA and the Engineered Wood Product manufacturer's in the UKTFA based on the research commissioned by the 3 organisations to find the location and root cause of the noise. The investigation was carried out by the University of Salford Acoustics Research Centre. The project is split into two separate phases – this statement reflects the findings and associated recommendations from Phase 1: identifying the location of the cracking noise.

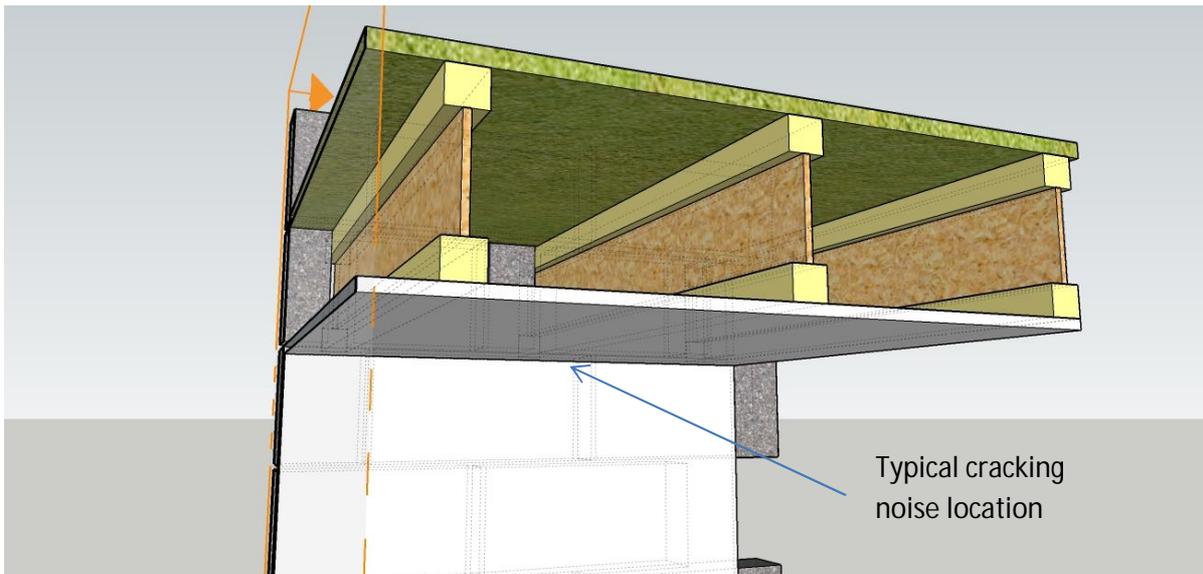
13. Based on the findings of Phase 1 of the research, in order to minimise the risk of such noise incidents occurring it is clear that particular care should be taken when constructing the junction between the blockwork wall, the wall/ceiling lining and the joists. Specifically, care should be taken to ensure that gypsum plasterboard adhesive plaster dabs do not spread up the back of the plasterboard and set in contact with the lower flange of the joist. For further details please refer to individual industry body or manufacturer websites.

4. In all 3 properties the source of each dominant repeatable cracking noise was tracked to the junction between the wall lining and the underside of the floor structure at the point where a floor joist was built into the wall.
