FIRE ALARM

Almost 20 years after a devastating World in Action exposé, the timber frame industry is back under the microscope. This time, government-backed research has found that poor workmanship is exposing occupants of timber frame buildings to potentially fatal fire risks. Thomas Lane and Andy Pearson report

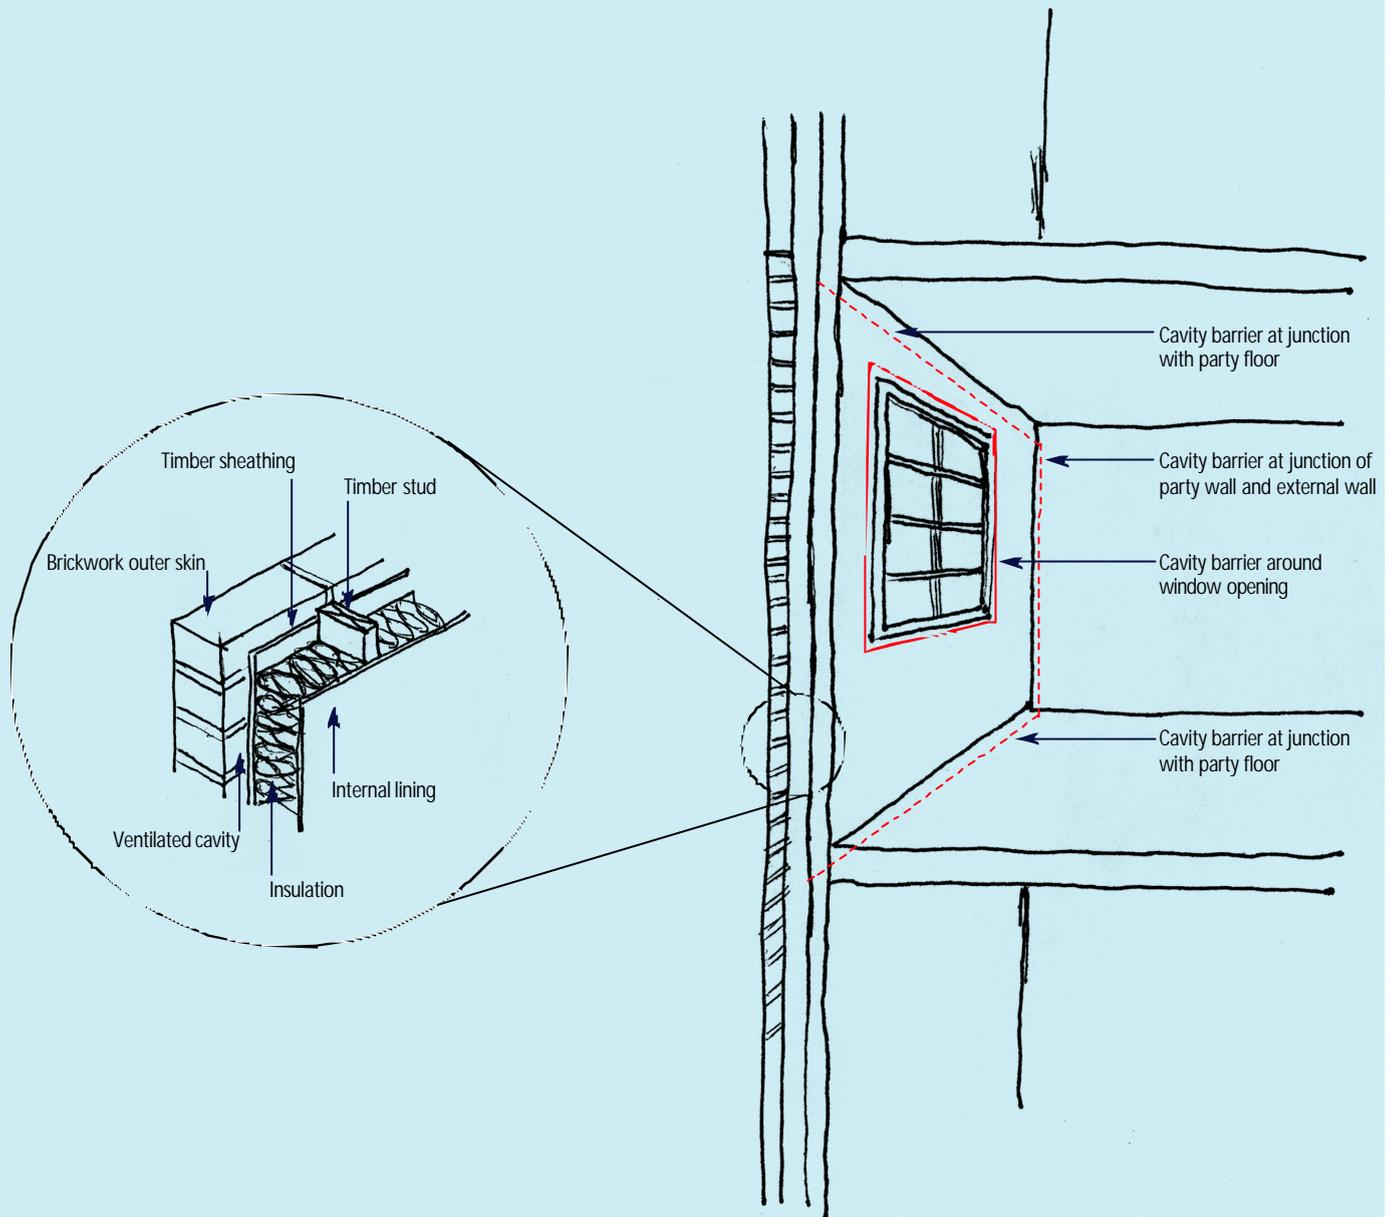
Where the cavity barriers are located: a multistorey residential building

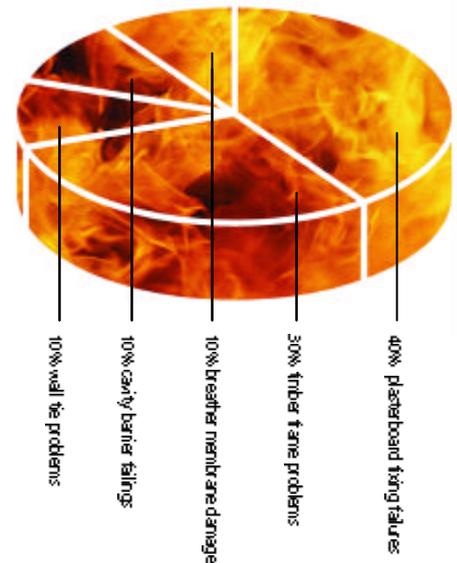
Where the industry is going wrong

Plasterboard fixing

- The wrong types of fixings are often used
- Fixings are sometimes incorrectly spaced
- The lower layer of plasterboard can be incorrectly fixed – boards attached with only the minimum of fixings
- Plasterboard joints are not staggered and the lower layer of boards have large gaps between
- Plasterboard noggins are incorrectly fixed, wrongly located or missing

- Even though the components of many timber frame constructions are fabricated in the factory, there are still problems with the correct installation and fixing of components
- Key structural elements are missing from constructions
- Galvanized steel fixings are used to secure stainless steel components
- Open perpenders are not installed above cavity barriers and apertures

- Installed at the wrong angle to allow drips to fall
- Installed with incorrect fixing
- Ties missing
